Center Speaker Cover Lifting

Service Category Vehicle Interior

Section Interior Panels/Trim

YEAR(S)	MODEL(S)	ADDITIONAL INFORMATION
2009	Venza

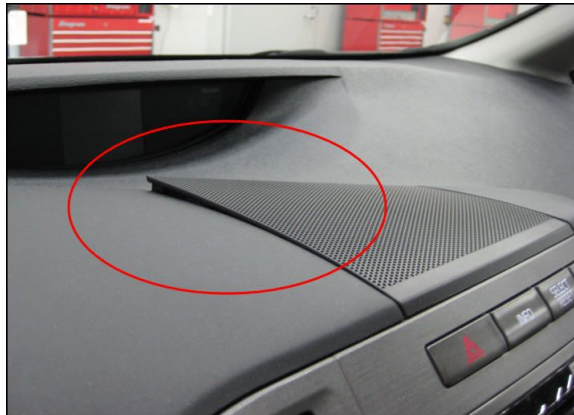
Figure 1.

Some 2009 model year Venza vehicles may exhibit a lifting condition of the center speaker cover as shown in the illustration. Perform the following procedure to improve this condition.

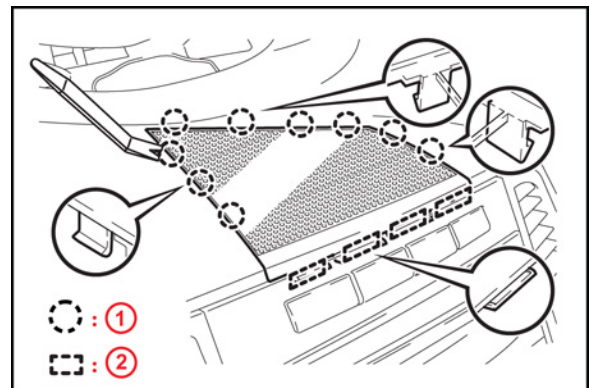
Figure 2.

1	Claws
2	Guides

1. Verify Complaint Condition.
2. Using a plastic pry tool, disengage the 9 claws and 4 guides and remove the No. 2 instrument panel speaker panel sub-assembly.

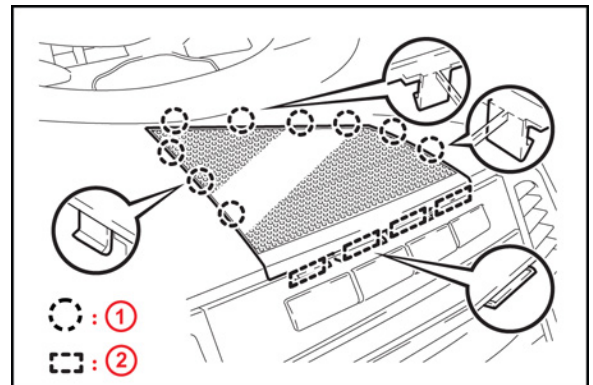
Figure 5.

1	Claws
2	Guides

4. Engage the 4 guides and 9 claws to install the No. 2 instrument panel speaker panel sub-assembly.
