# Repair Manual Supplement: Vehicle Pulling to One Side

**Service Category** Suspension

**Section** Alignment/Handling Diagnoses

### TSB SUPERSESSION NOTICE

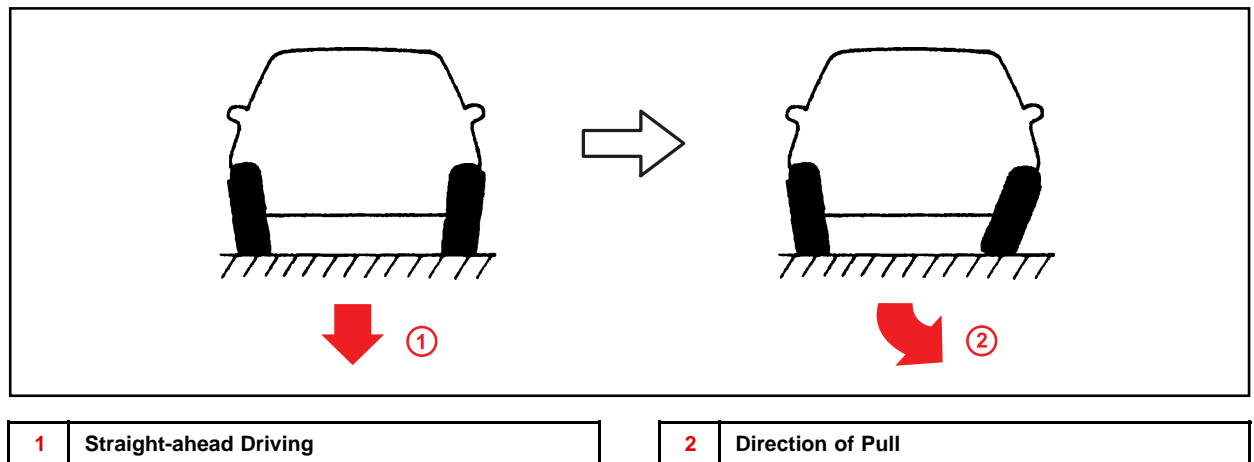
**Figure 1. Camber**

When the cross camber or caster of the front wheel alignment is large, it can cause vehicle pulling.

WHEEL ALIGNMENT	DIRECTION OF VEHICLE PULLING
Camber	Vehicle Pulls in Direction of Wheel with Large Camber Value (See Figure 1)
Caster	Vehicle Pulls in Direction of Wheel with Small Caster Value (See Figure 2)

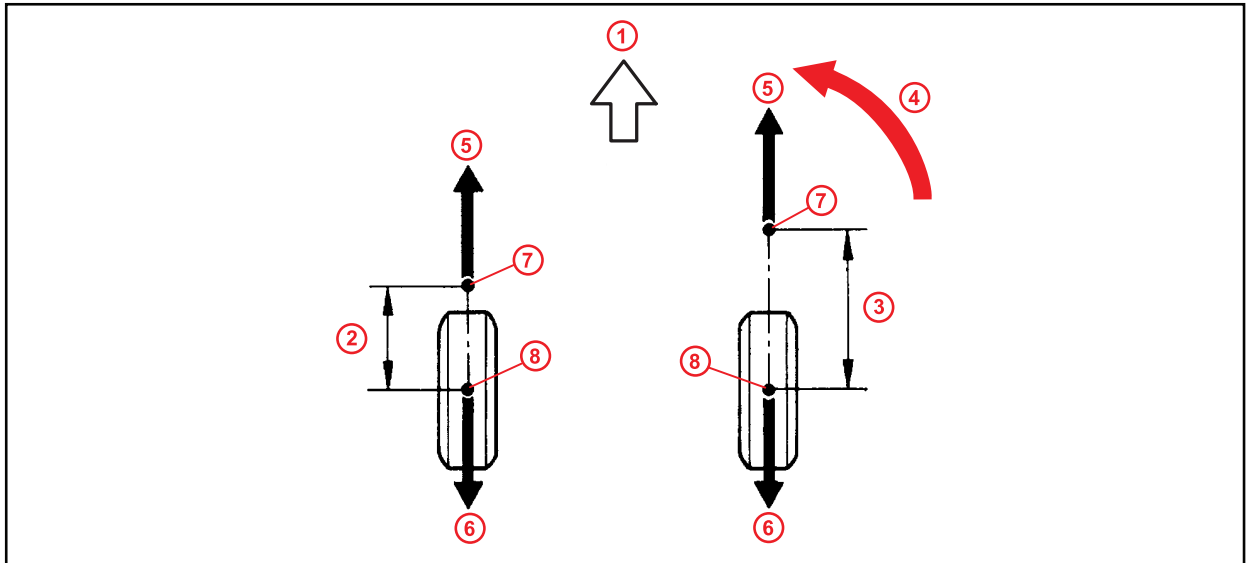
**Figure 2. Caster**

If the cross camber or caster is within the specified range (30' or less), noticeable vehicle pulling will not occur due to side-to-side differences in camber or caster.

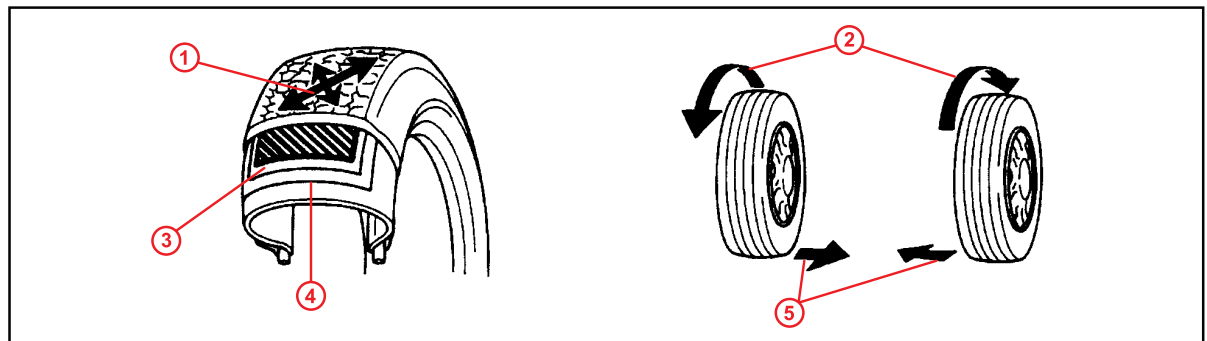
**Figure 3.**

Lateral force due to ply-steer is produced by the construction of the belts inside the tire tread. With radial tires, the wire of the belt is slanted as shown in the illustration below. Thus, it is in the lateral direction that tire tread easily changes shape (stretches), and lateral force is generated between the tire and the road surface in the lateral direction.

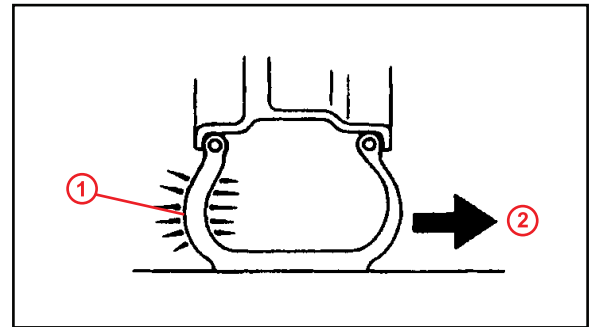
Figure 4.

Conicity is lateral force resulting from uneven formation of the left and right sides of the tire. The direction the lateral force is exerted depends on the hardness of the side walls and the difference in height between the left/right sides of the tire.

- In the case of vehicle pulling caused by tires, the lateral force which is exerted as a result of conicity has the greatest effect. On a flat road, if the steering wheel is held without exerting steering effort for 109 yards (100 m) when traveling at 62 mph (100 km/h), the vehicle may drift as much as 5 feet (1.5 m).
- When vehicle pulling is due to conicity, the amount of drift can be reduced and the direction of drift can be changed by changing the location of the tire or reversing the tire when installing it on the wheel.

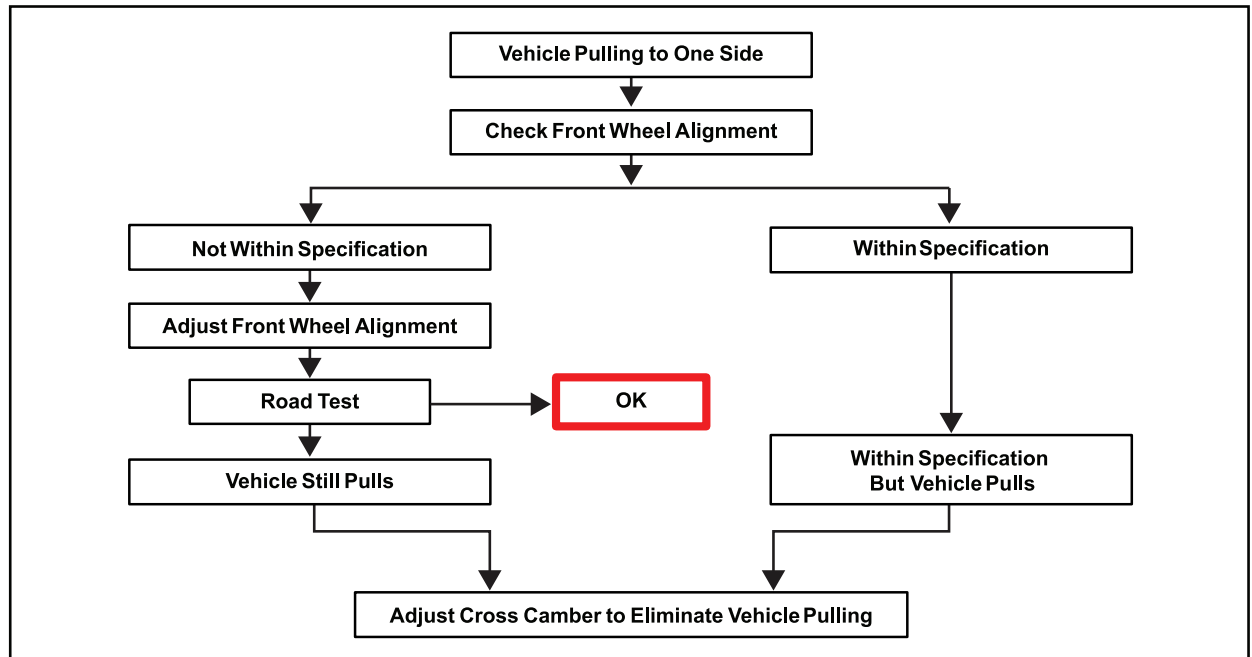
**Figure 8.**

When it is determined by troubleshooting that the vehicle pulling to one side is caused by wheel alignment, perform repairs according to the following procedure.

WHEN VEHICLE PULLS TO LEFT	WHEN VEHICLE PULLS TO RIGHT
Increase right front camber and decrease left front camber until vehicle pulling is eliminated	Increase left front camber and decrease right front camber until vehicle pulling is eliminated

- Keep the cross camber within 1° or less.
- Keep the camber of each wheel within specifications (+/-45' of center value).
- If adjustment exceeds the specifications, uneven tire wear will result.

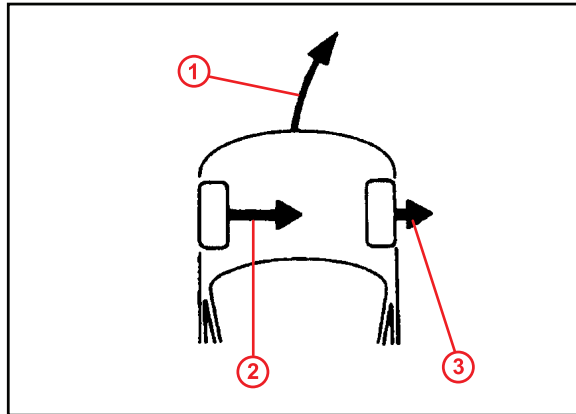
**Figure 11. Original Tire Positions**

The lateral force generated by the left front tire is greater than the right tire, so the vehicle is pulling due to the lateral force of the left tire.
