# Upper/Lower Windshield/Rear Glass Tick Noise

The information contained in this TSB supersedes TSB No. NV009–06.

## Upper/Lower Windshield/Rear Glass Tick Noise

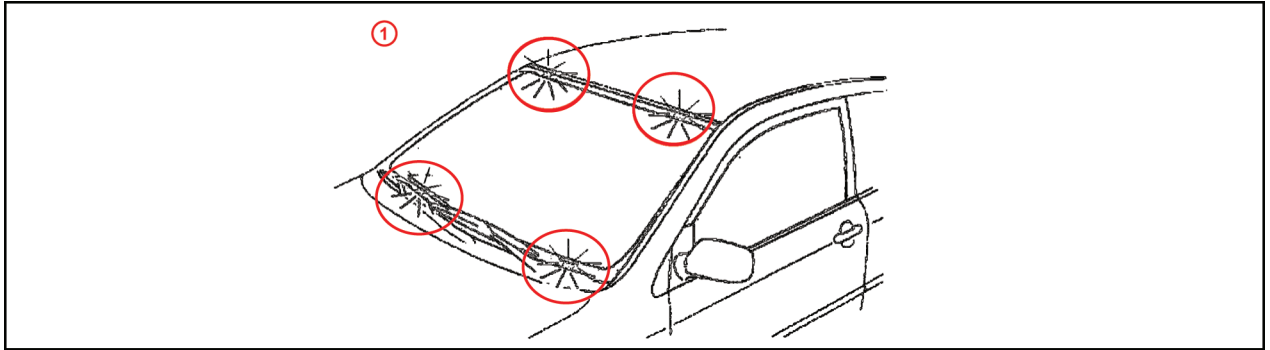
Figure 1.

1	Pin Locations
---	---------------

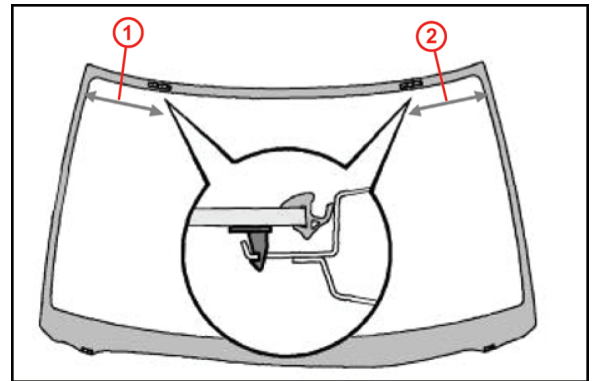
Figure 2.

The stoppers are located on the inside of the passenger compartment behind the windshield glass blackout section (near the top front edge of the metal roof opening). The stoppers are typically located 20 – 25 cm (7.9 – 9.8 in.) inboard of the top corners of the windshield glass.

1	20-25 cm (7.9-9.8 in.)
2	20-25 cm (7.9-9.8 in.)

1. Remove both sun visors and both A-pillar garnishes, and then carefully lower the front of the headliner to gain access to the windshield stoppers (refer to the appropriate model year Repair Manual for the proper procedure).

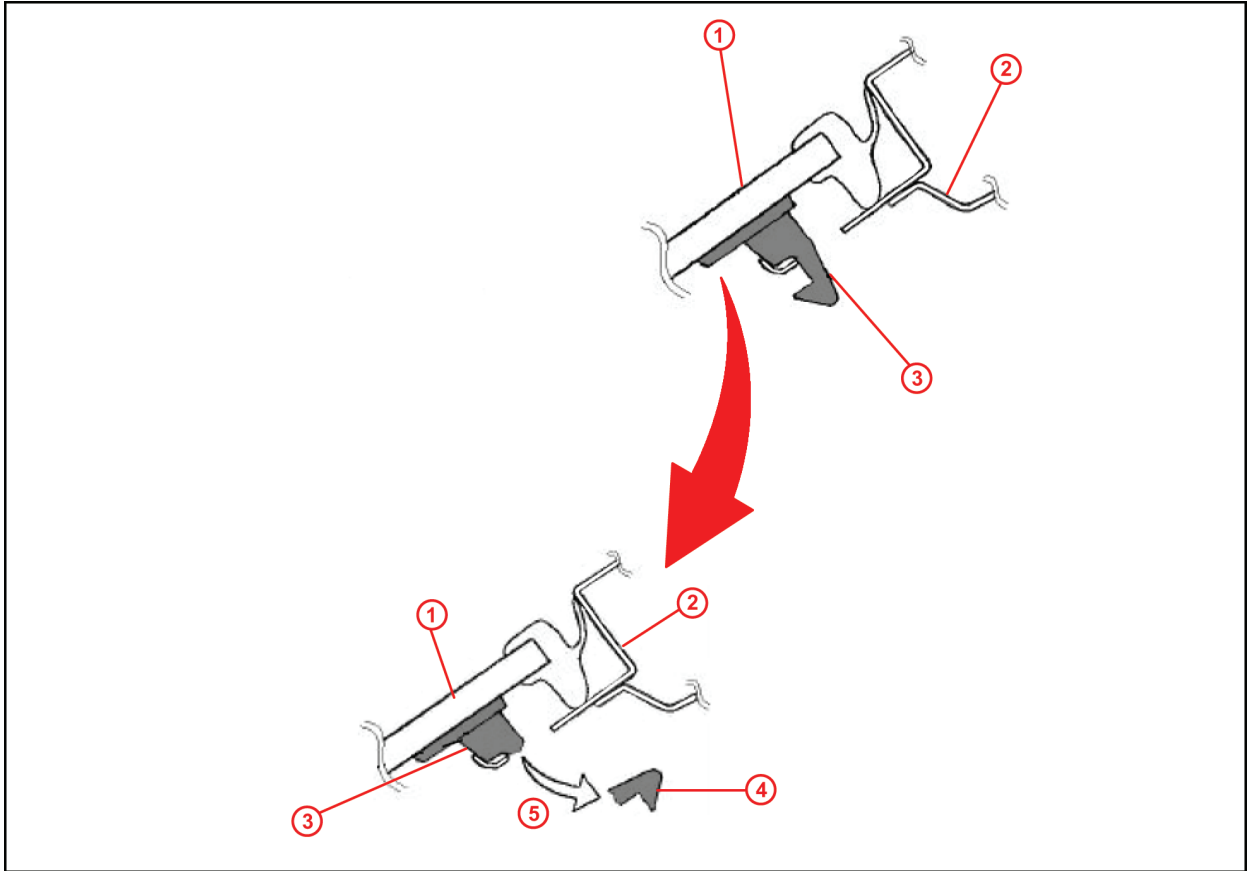
**Figure 3.**

1	Windshield Glass
2	Roof Panel
3	Glass Stopper

4	Cut
5	Fragment of Glass Stopper

2. Cut OFF the tip of the plastic stopper as shown in Figure 3.

It is sometimes necessary to bend the metal body tab down to gain access to the shaft of the stopper.

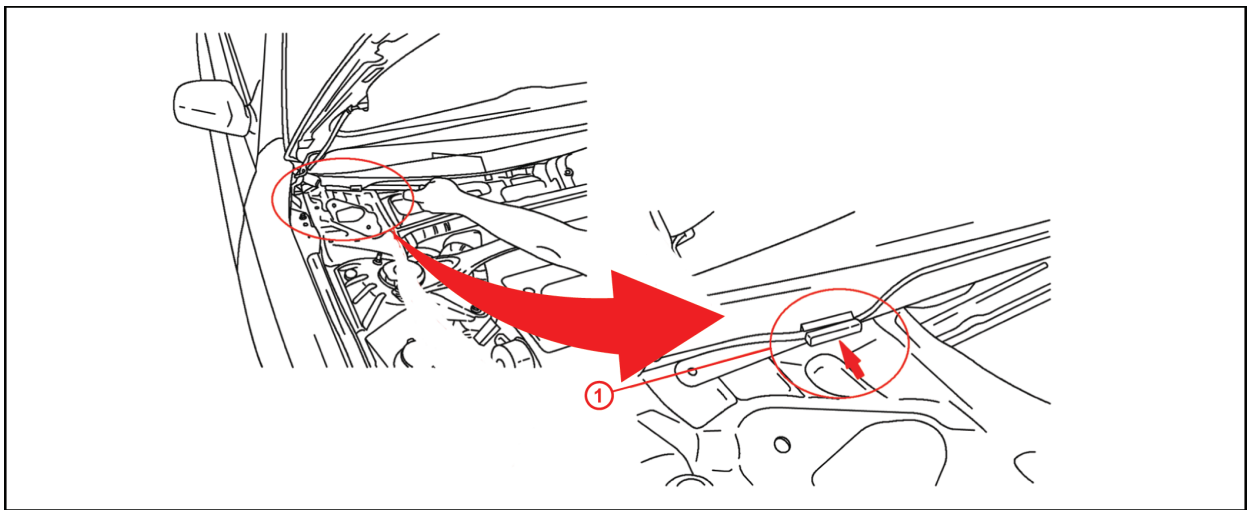
**Figure 6.**

The retainers are typically located 140 – 200 mm (5.5 – 7.9 in.) inboard of the lower corners of the windshield. The flat portion of the retainer is adhered to the backside of the windshield with double-sided, foam-backed tape.

<b>1</b>	Pin is attached to plastic block underneath windshield
----------	--

3. Use a "Mini" Hacksaw with a fine tooth 10-inch blade to cut OFF the pin portion of the glass retainer flush with the flat portion of the windshield retainer as shown in Figure 6.

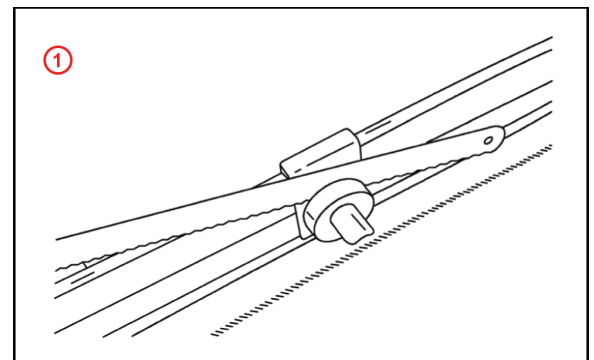
**Figure 7.**

<b>1</b>	View from underneath windshield
----------	---------------------------------
