Rattle Noise From Center Of Instrument Panel

YEAR(S)	MODEL(S)	ADDITIONAL INFORMATION
2009 – 2010	Venza

Some 2009 – 2010 Venza vehicles may exhibit a rattle condition from the center of the instrument panel. Use the following procedure to correct this condition.

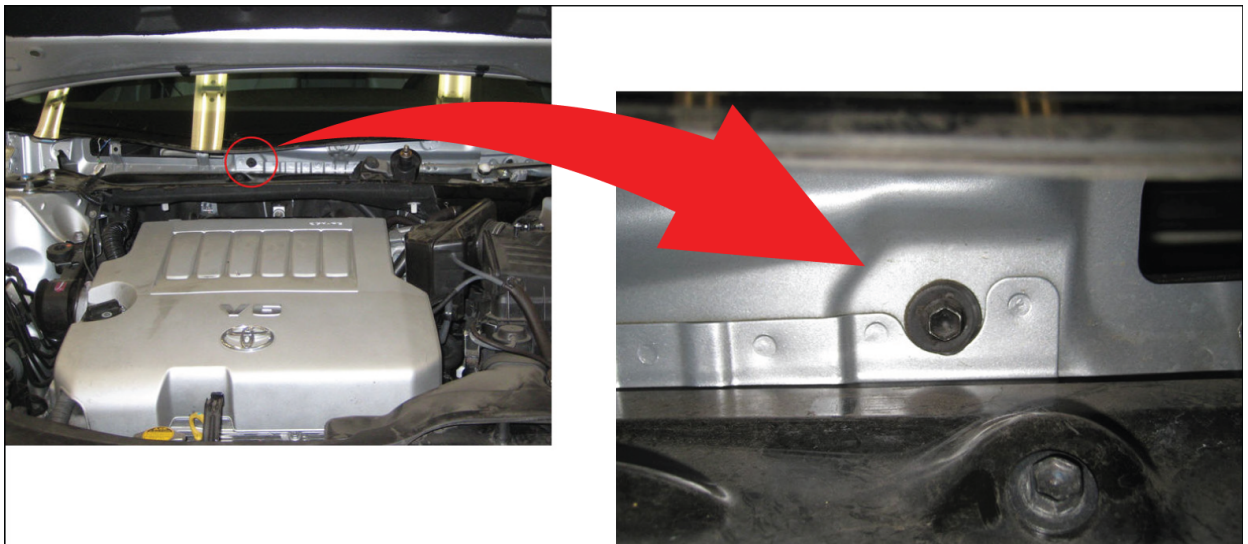
Figure 7.

- 7. Remove the RH Instrument Panel Reinforcement Mounting Bolt and inspect for a loose or cross threaded condition.

8. If the bolt is found loose, reinstall and tighten.
9. If the bolt is found cross threaded, clean the threads with 6 mm x 1.0 pitch tap and replace the bolt and tighten.

Torque: 17 N*m (175 kgf*cm, 13 ft*lbf)

Ensure the rubber washer on the bolt is compressed to properly seal the hole.
