Cross Bar Wind Noise

Service Category Vehicle Exterior

YEAR(S)	MODEL(S)	ADDITIONAL INFORMATION
2009 – 2010	Venza

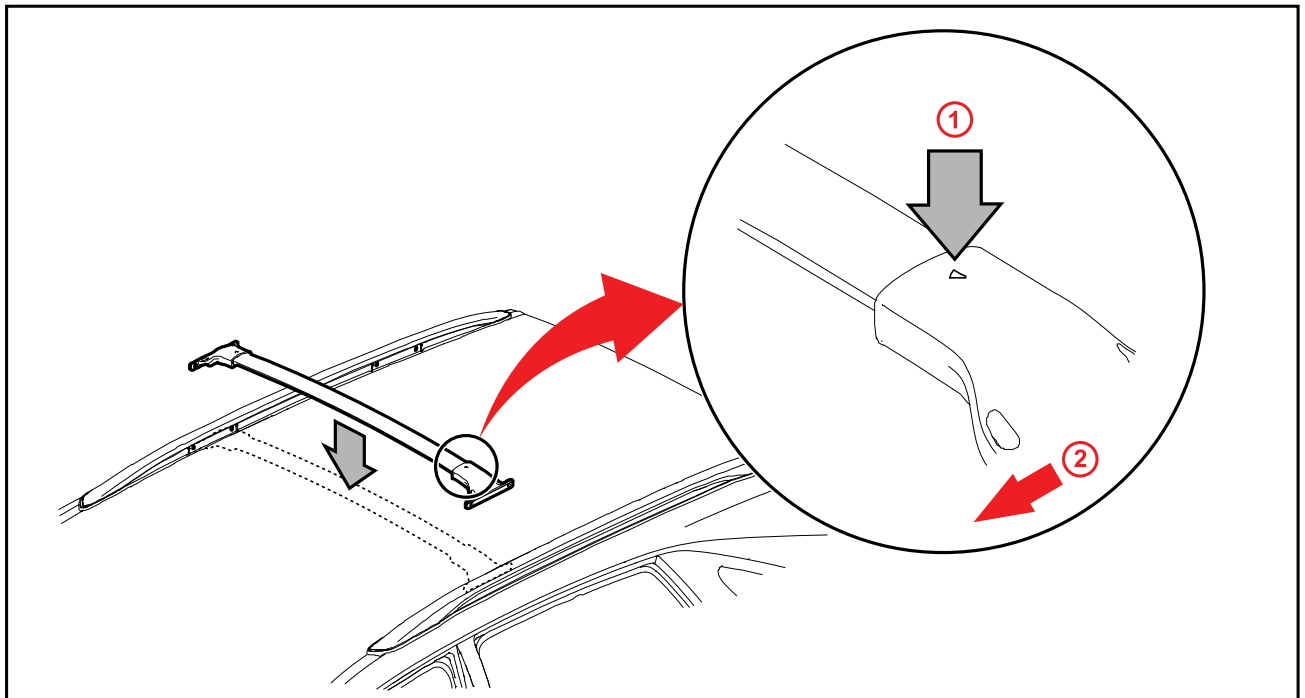
Figure 1.

2009 – 2010 model year Venza vehicles equipped with accessory roof rack and cross bar assemblies (P/N PT278-0T090) may exhibit a wind noise condition described as a whistling or howling. The noise can occur at low to high speeds.

1 Triangle Direction Arrow

2 Front of Vehicle

Ensure the front and rear cross bar assemblies are installed correctly. The tip of the marking triangle should point toward the front of the vehicle.
