# Repair Manual Supplement: Vehicle Pulling to One Side

**Service Category** Suspension

**Section** Alignment/Handling Diagnoses

### TSB SUPERSESSION NOTICE

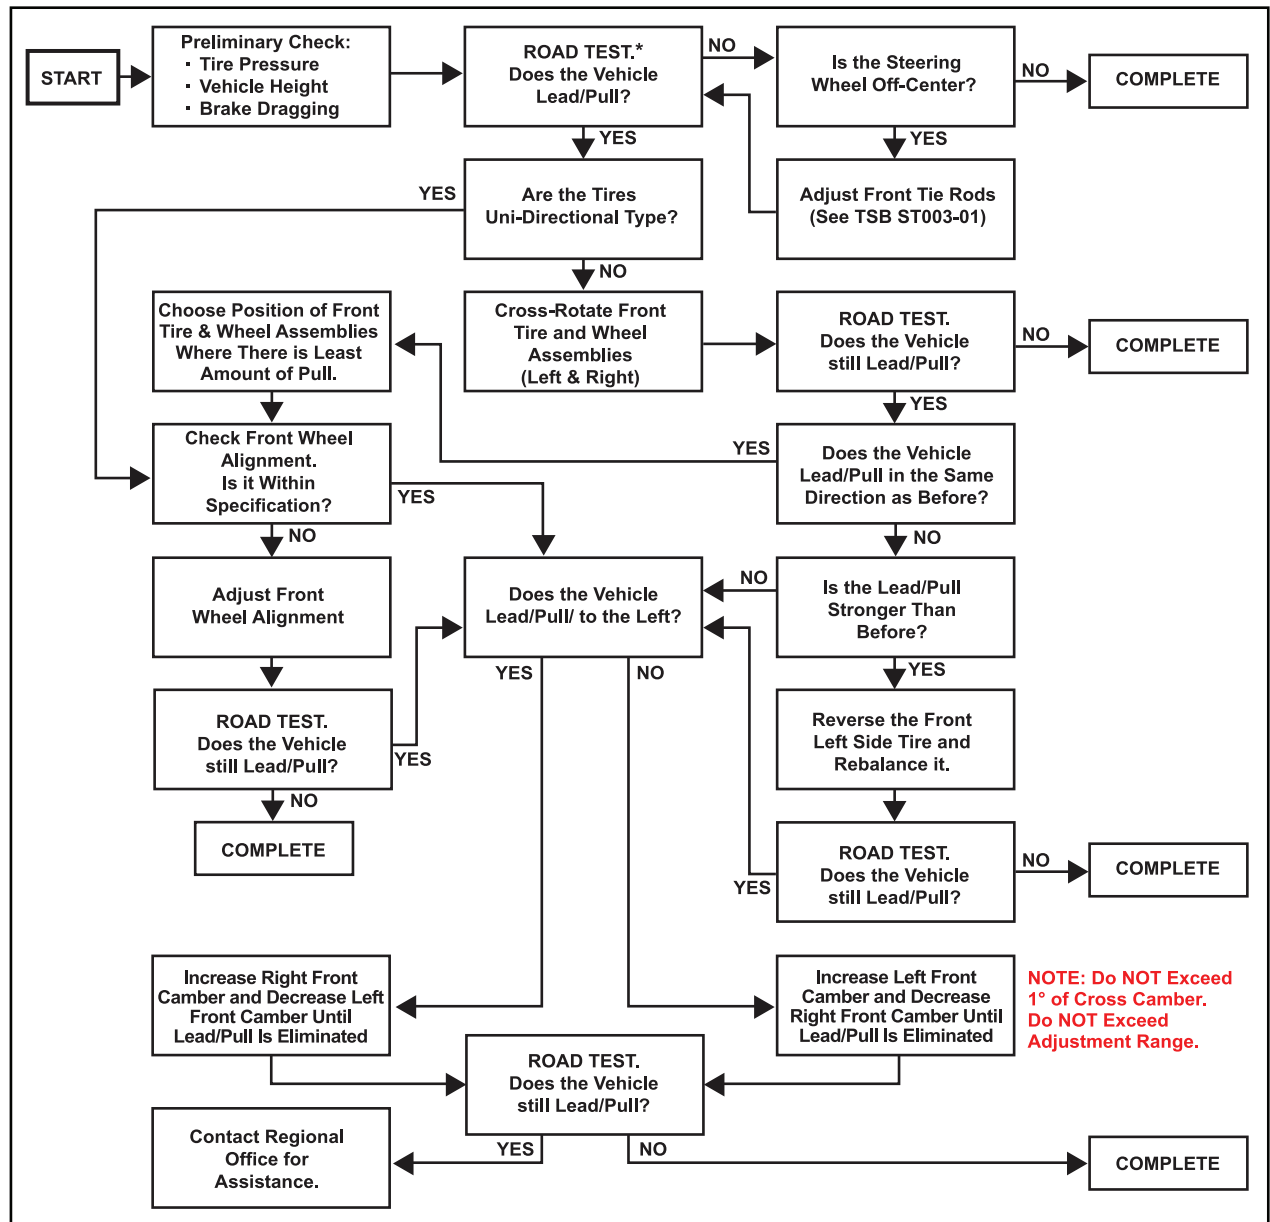
Figure 5.

\* Select a flat road where the vehicle can be driven in a straight line for 109 yards (100 meters) at a constant speed of 35 mph (56 km/h). Please confirm safety and set the steering wheel to its straight position. Drive the vehicle in a straight line for 109 yards (100 meters) at a constant speed of 35 mph (56 km/h) without exerting steering effort on the steering wheel.

- Steering Off Center: The vehicle goes straight but the steering wheel has some angle.
- Steering Pull: The vehicle does NOT go straight.
